ommander's Hazard Identification

Ground Operations & Equipment

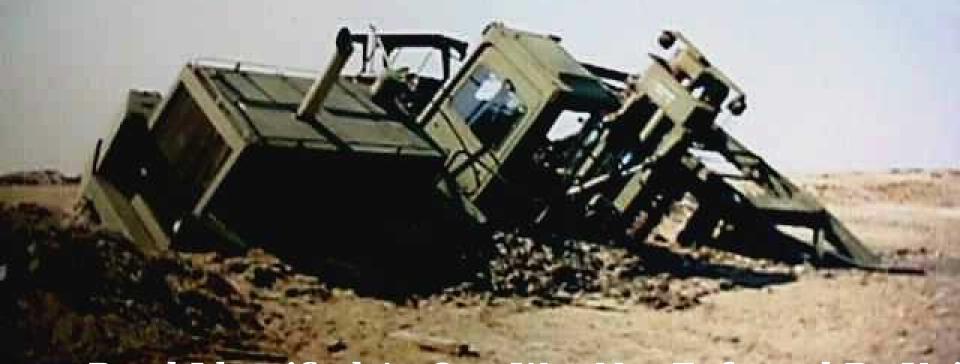
Slide Two

Road Identified As One Way Not Enforced By Uni This Put Operator In A Misjudgment Situation. Slide One

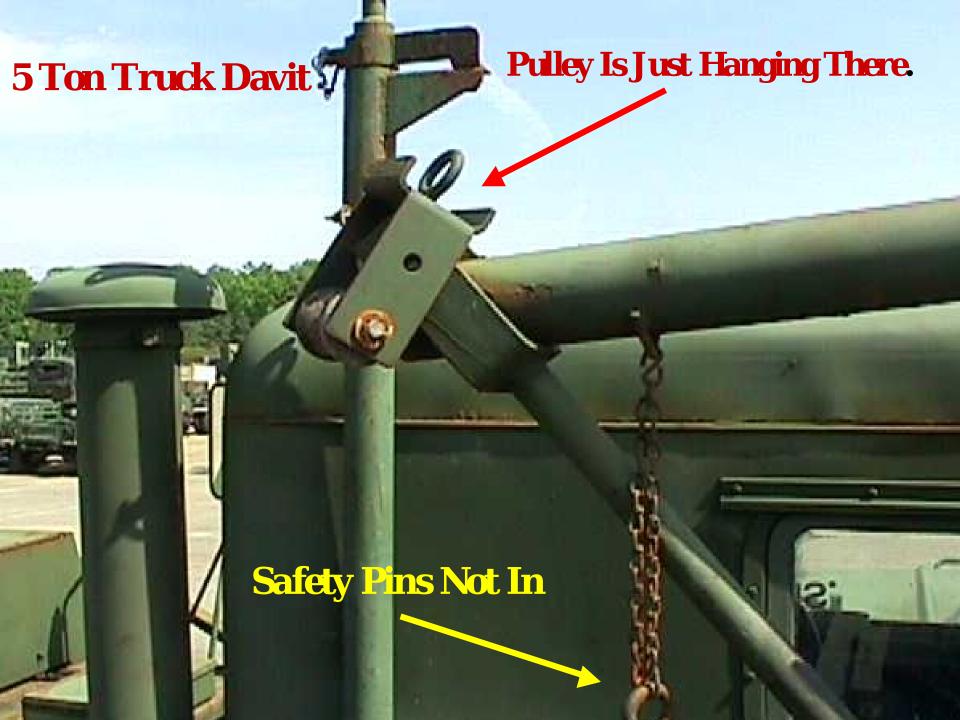
5 Ton Truck Davi

2nd Safety Pin Not In

Davit Is Ready Fall Out & Off When Vibrated Dropoed On A V Load Of Kids
